Manhole Inspection Summary

Manhole # S35SS_012MH

Insp Date: 1/12/07 12:57 PM

Location Address: **2617 BARCLAY ST**

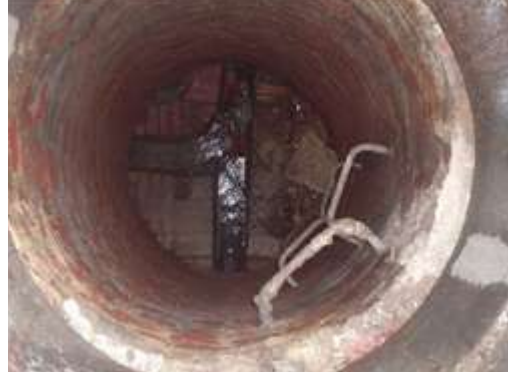
Top View

Corroded steps. Evidence of surcharge - Bench debris. Channel debris.

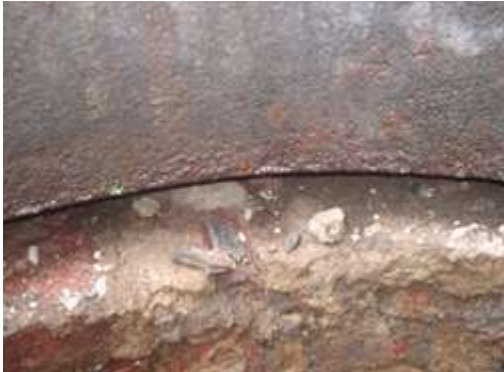
Defect

Frame leaks. Adjustment deterioration and infiltration.

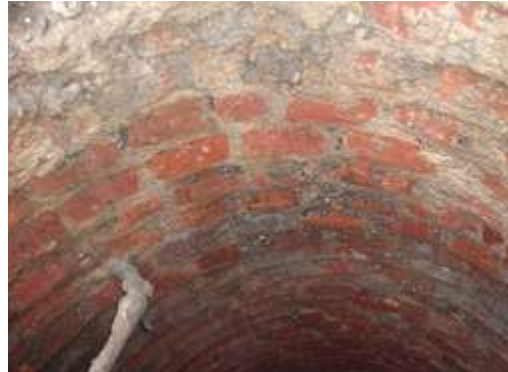
Defect

Adjustment deterioration and infiltration. Corbel infiltration.

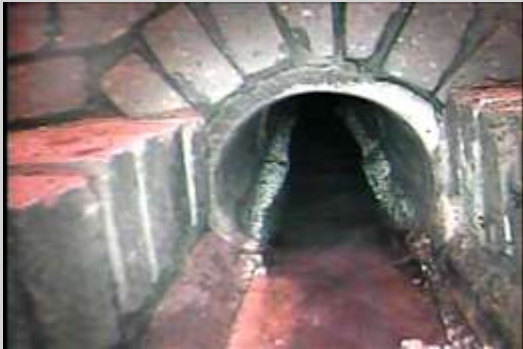
8 in. Circular Gravity Sewer Pipe Out @ 12 O'Clock

Deposits: ☐ None ☒ **Mud** ☐ Sludge ☐ Debris ☒ **Grease**

Infiltration: **Evidence** Pipe Seal Cond: **Unknown**

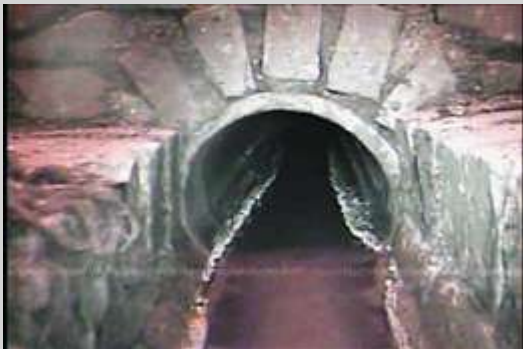
8 in. Circular Gravity Sewer Pipe In @ 6 O'Clock

Deposits: ☐ None ☐ Mud ☐ Sludge ☐ Debris ☒ **Grease**

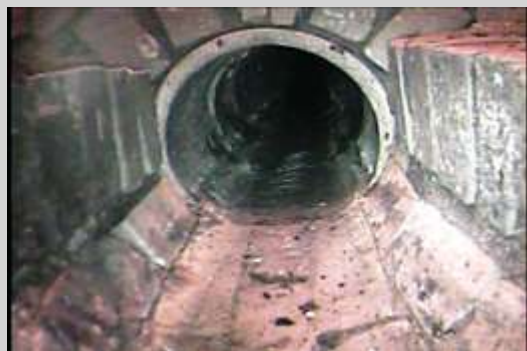
Pipe In @ 9 O'Clock

Channel deterioration.

Deposits: ☐ None ☐ Mud ☐ Sludge ☐ Debris ☒ **Grease**
